**Lower Butte Creek – Sutter Bypass
Willow Slough Weir
Fish Passage Project**

**Preliminary Engineering
Technical Report**

February 2005

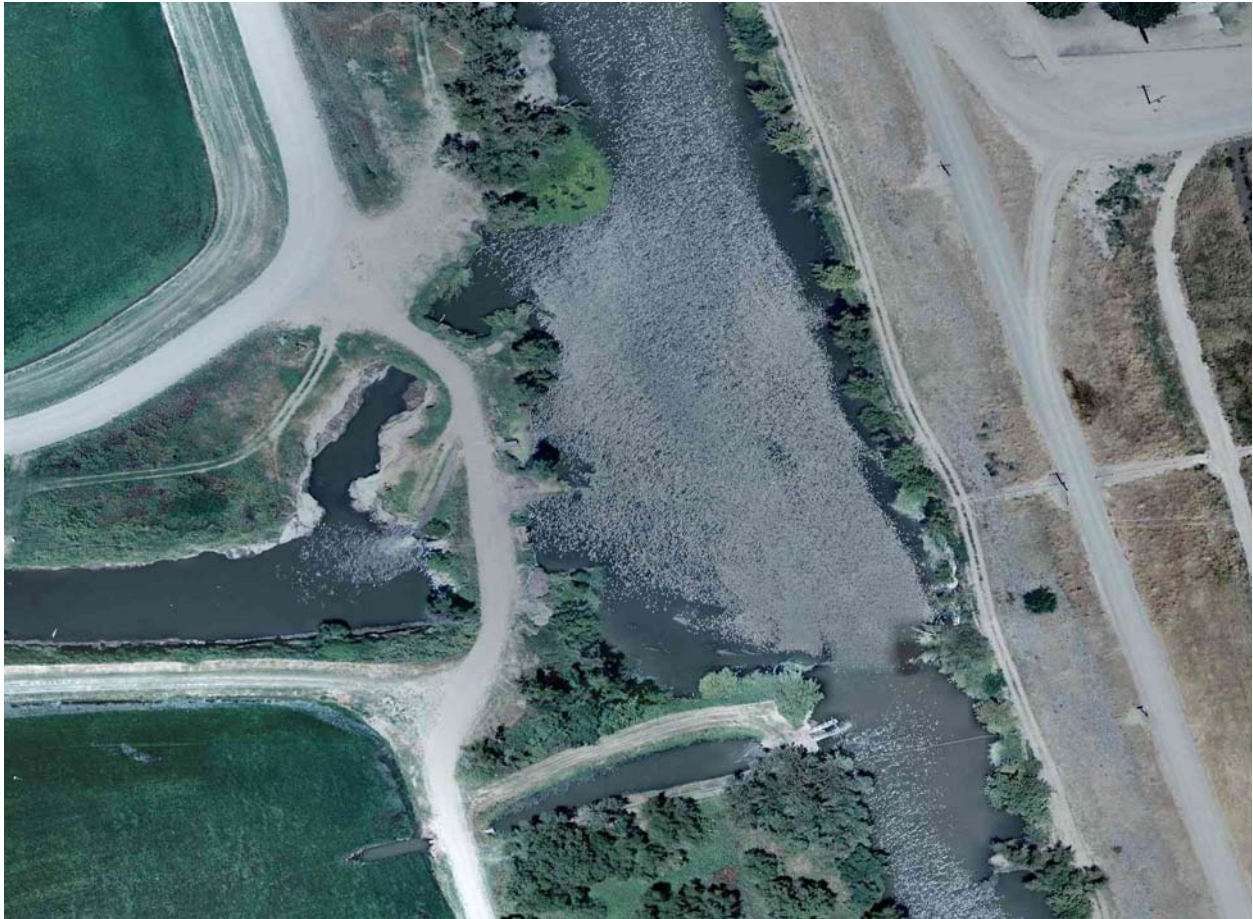
Figure 1. Aerial photograph of Willow Slough Weir.

Willow Slough Weir is an earthen dam with two 60-inch diameter corrugated metal pipe (CMP) culverts and one 60-inch diameter reinforced concrete culvert with slide gates that control flow from the lower end of the EBC into Willow Slough. The structure was constructed between 1924 and 1925 under the direction of the Reclamation Board to control water levels in the EBC so that irrigation water could be supplied to local farmers. A Denil fish ladder was constructed through the weir in the 1980s. The structure is owned, operated, and maintained by DWR. An aerial photograph of the project site is shown (Figure 1).

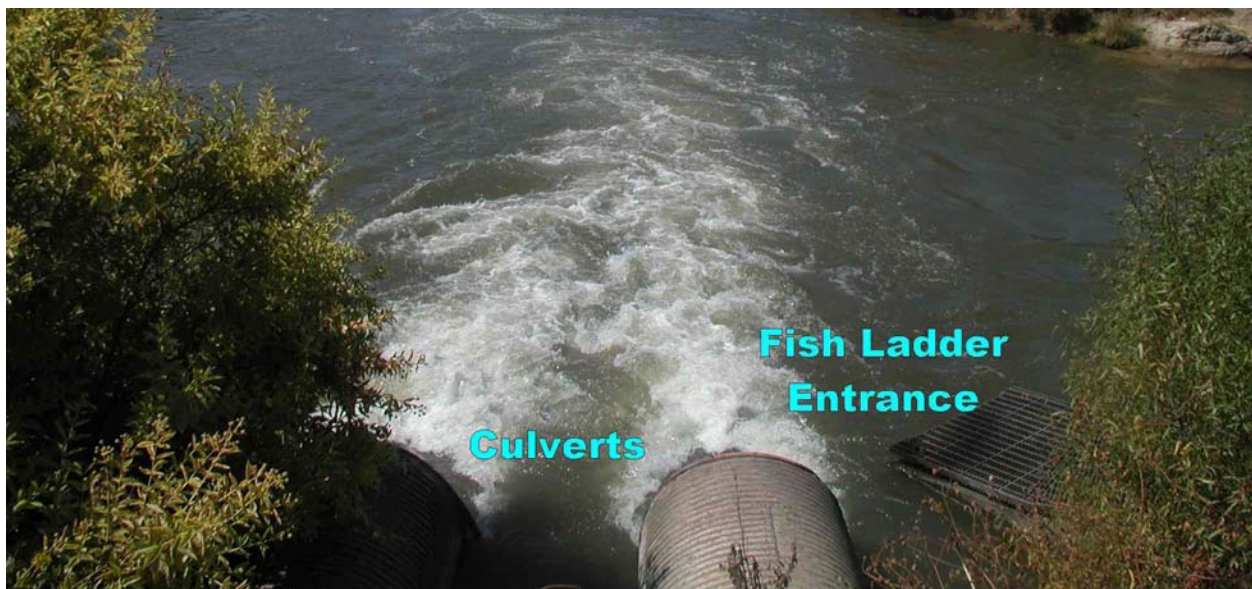
Figure 3. Existing culverts and fish ladder entrance.

The first problem identified with the existing Denil fish ladder is the lack of attraction flow compared with flows being discharged through the culverts into Willow Slough (Figure 3). The relatively high discharge through the culverts causes fish to be attracted to the culverts instead of to the Denil fish ladder. The culverts are mostly impassable because of high velocities in the culverts resulting from the typical 9-foot head differential between the EBC and Willow Slough. Salmonids are not only delayed by the culvert flows, but also waste energy jumping at the high velocity flows.

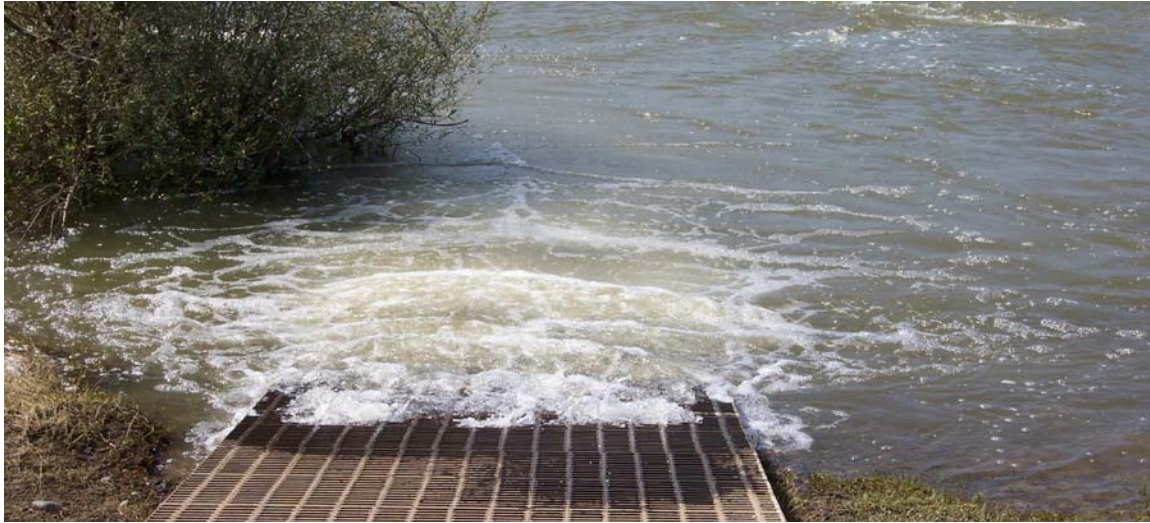
Figure 4. Existing Denil fish ladder entrance submerged.

The second problem identified is the elevation of the entrance into the Denil fish ladder. When the water surface elevation in Willow Slough is greater than 22.2 feet U.S. Engineering Datum (USED), the fish ladder entrance is submerged (Figure 4). Salmon have been observed jumping at the entrance to the Denil fish ladder, over-shooting it, and landing on the grating on top of the fish ladder.

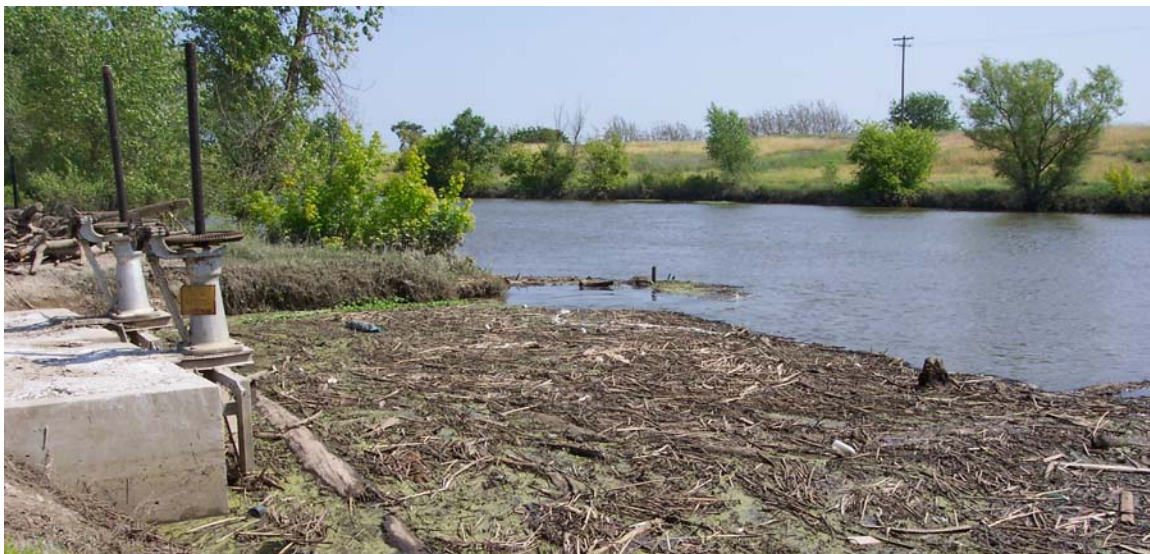
Figure 5. Debris problem in the EBC, Sutter Bypass.

The third problem identified is the debris in the EBC (Figure 5). Although the fish ladder exit is submerged, debris is able to enter the fish ladder and cause damage. Figure 6 illustrates the damage that has occurred to the baffles by debris. Debris can also get lodged in the headgates of the fish ladder and culverts and cause high velocities that hinder fish passage. During spring, Sutter Maintenance Yard (SMY) personnel dewater the fish ladder and repair any damage that may have occurred within that year.

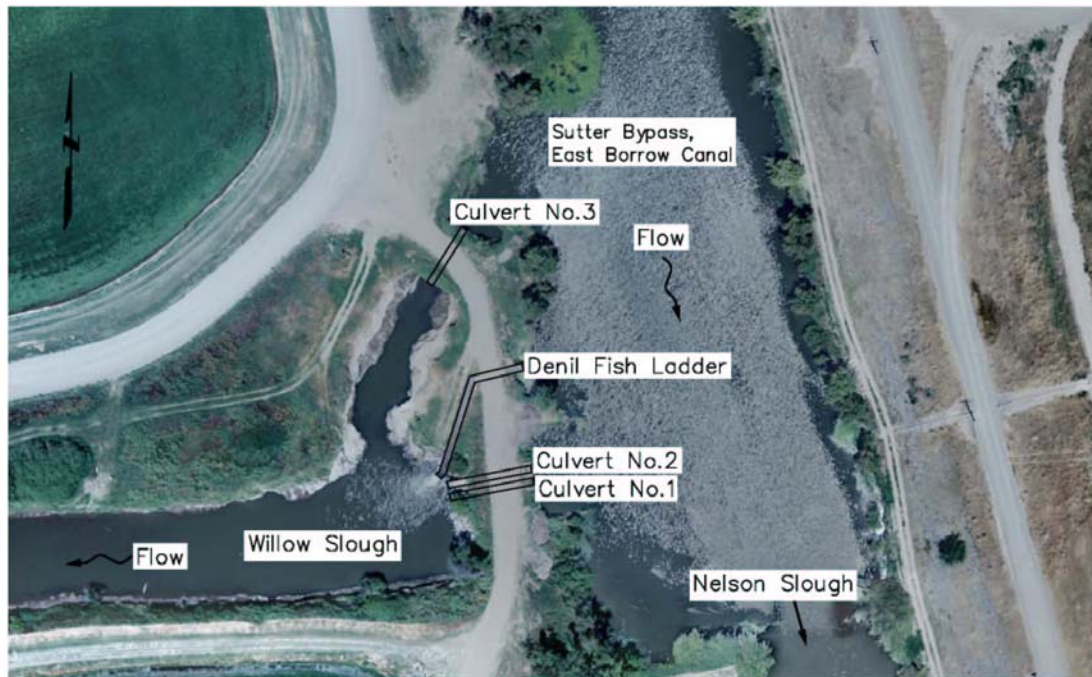
Figure 8. Existing fish ladder and culvert configuration.

According to the draft operations manual, SMY staff maintains the normal water surface elevation in the EBC at the location of PP1 between a stage of 27.5 feet and 29.5 feet (USED). The first and last water surface elevation adjustments to be made at Willow Slough Weir are made at the existing fish ladder to maximize fish passage. With the fish ladder wide open, adjustments thereafter are made first at culverts nos. 1 and 2, then culvert no. 3. When all the gates are open and the water surface elevation in the EBC is rising, water starts spilling into Nelson Slough downstream of Willow Slough in the EBC at a stage of 29.7 feet (USED). Figure 8 identifies the existing fish ladder and culvert configuration.

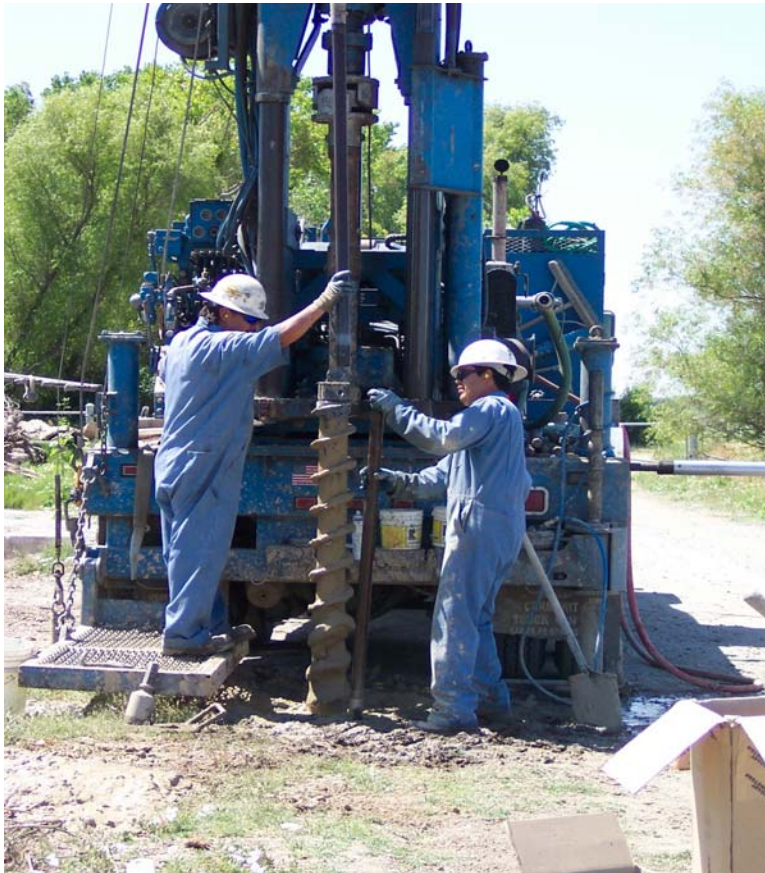
Figure 9. Auger drilling at Willow Slough Weir.

site were completed in June 2003 (Figure 9). Soil classification and Standard Penetration Test blow counts were recorded during the exploration work. Shelby Tubes were used to collect soil samples at 5-foot increments from each of the auger holes for lab testing. Appendix D contains the memorandum summarizing the results of the geologic exploration.

The information collected from the two boring holes indicates a wide range of soil types and are inconsistent with each other. Although the two bore holes were drilled approximately 70 feet apart, the results varied enough to warrant concern and possibly to drill another hole during final design.

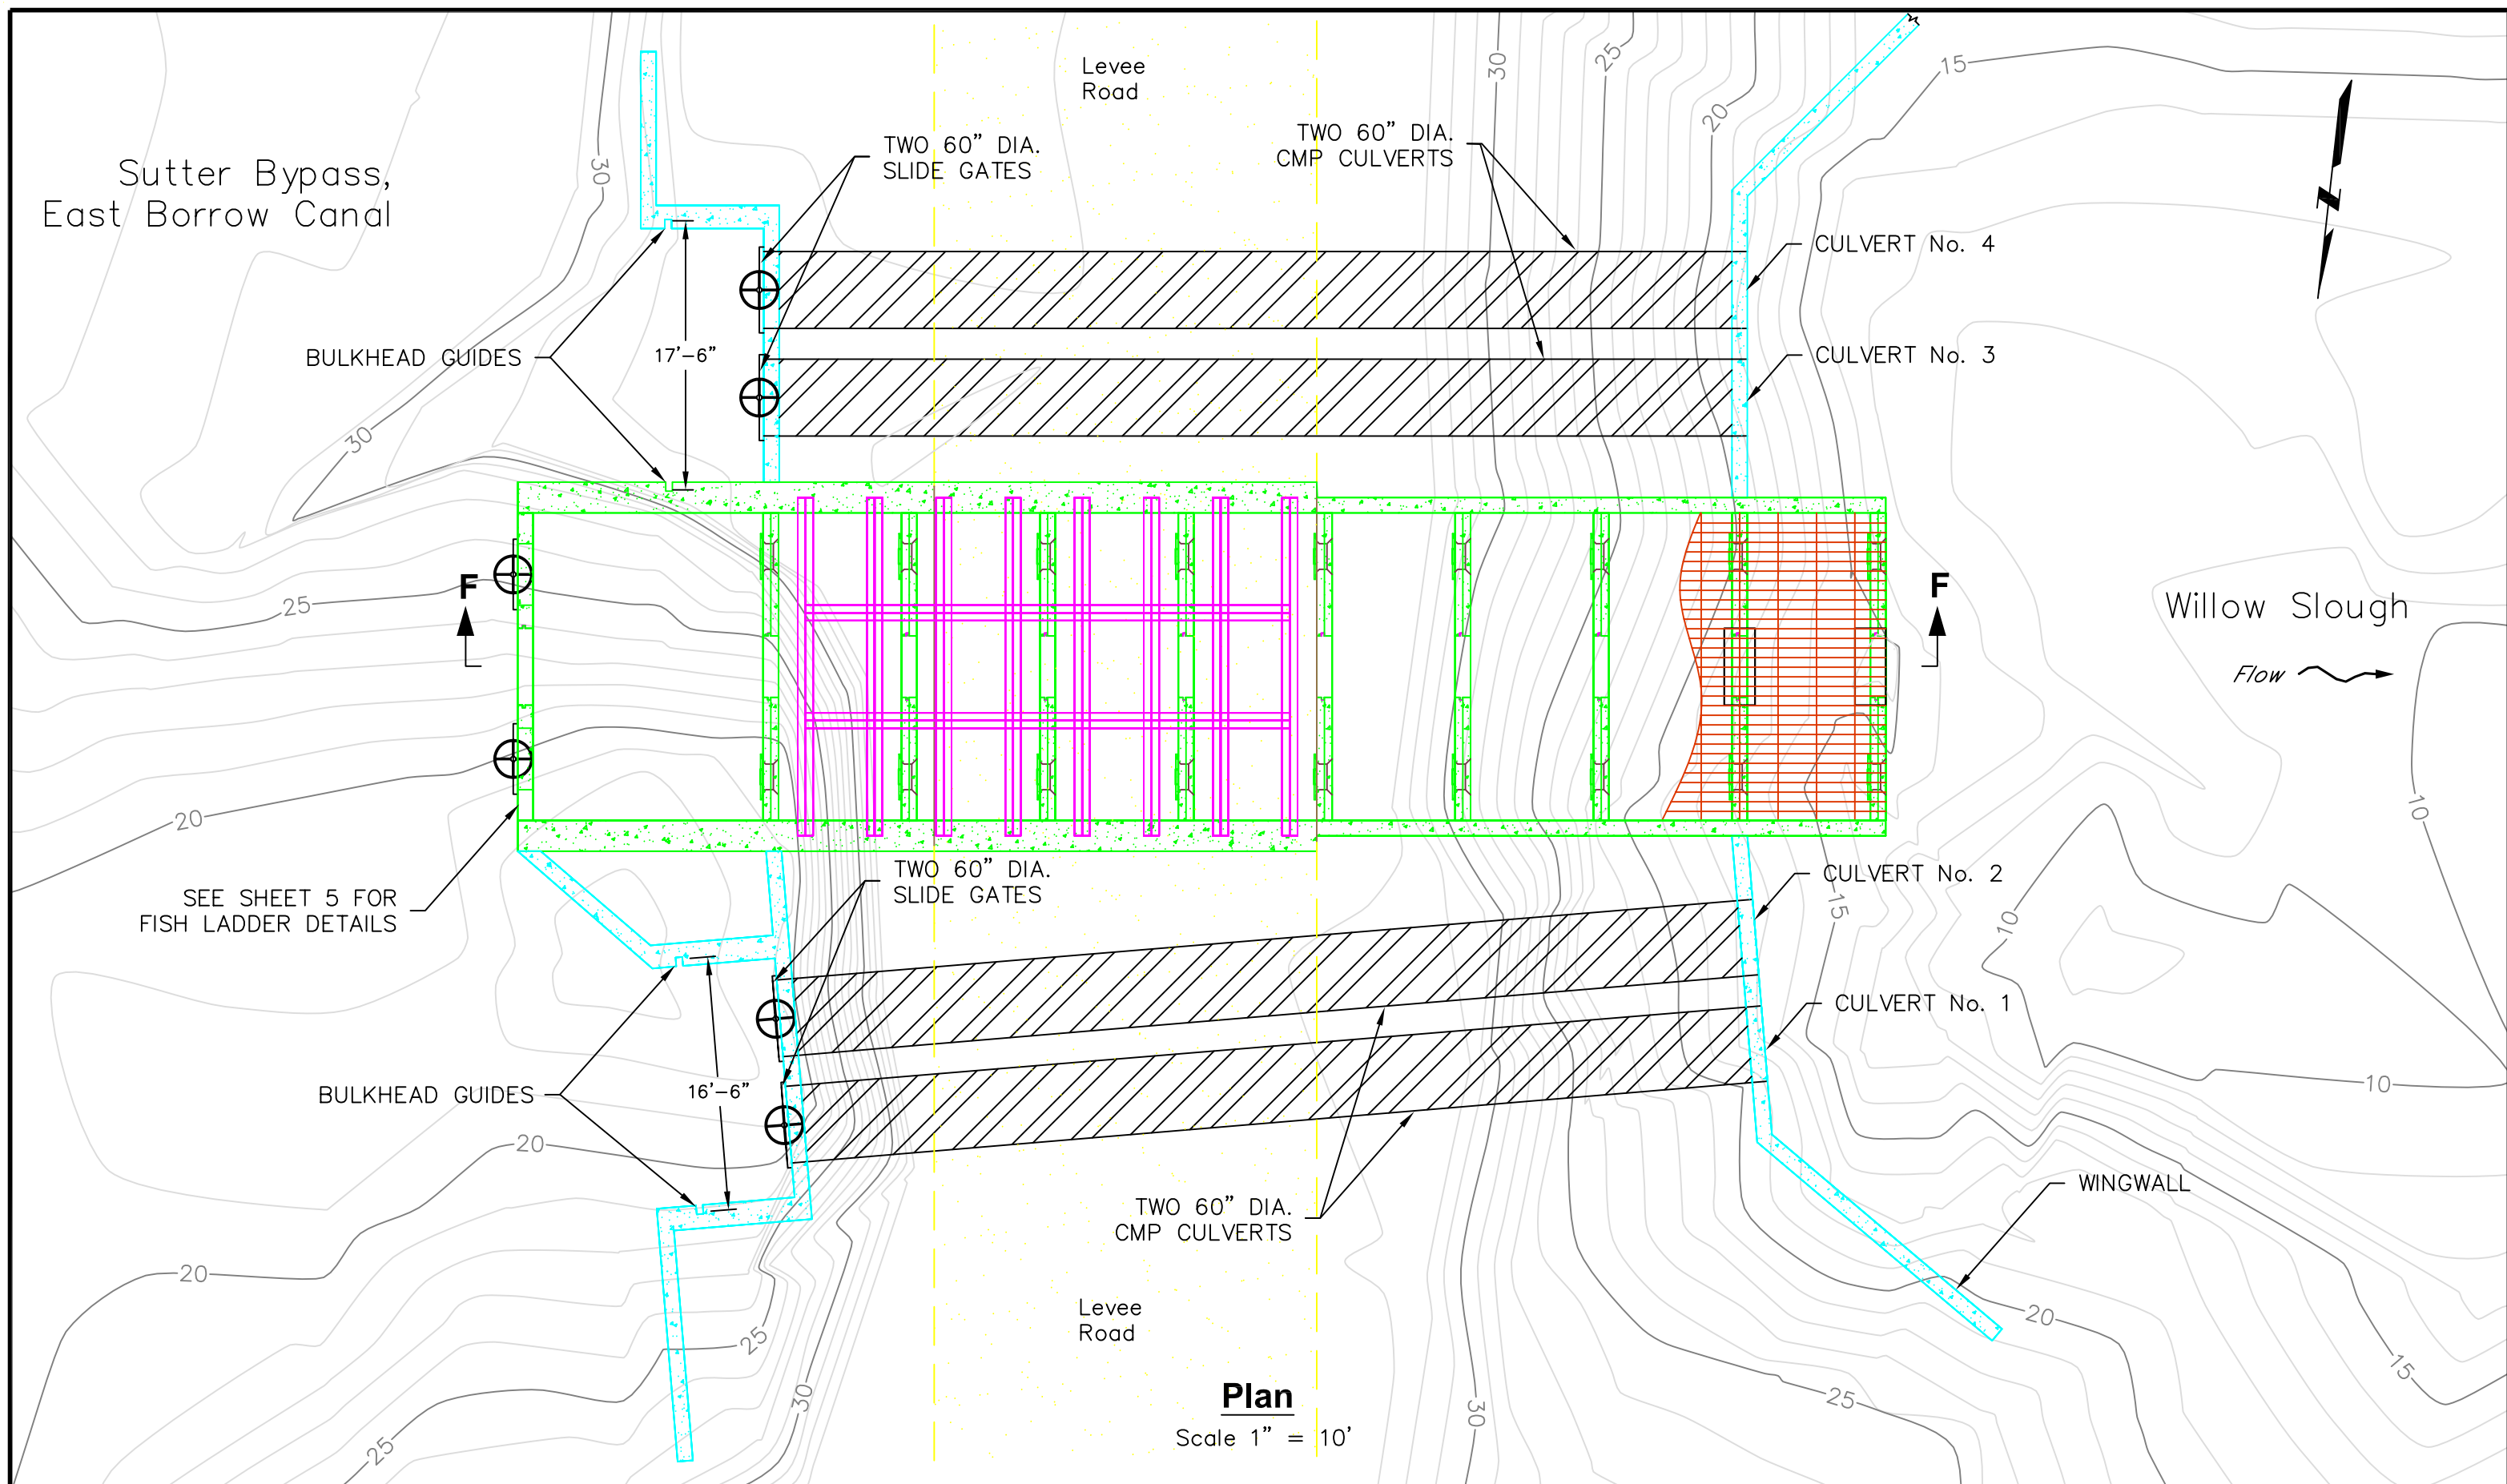
Flow Control Structure Plan

The proposed flow control structure consists of four 60-inch diameter CMP culverts with slide gates (Sheet 7). The culverts are approximately 65 feet long with a slope of about 2 percent (Sheet 8). When the water surface elevation in the EBC is 29.0 feet (USED) and the exit of the culverts are not submerged, the head difference is approximately 9 feet. When this condition exists, neglecting minor losses, the maximum flow in each culvert is approximately 290 cfs for a total of 1160 cfs.

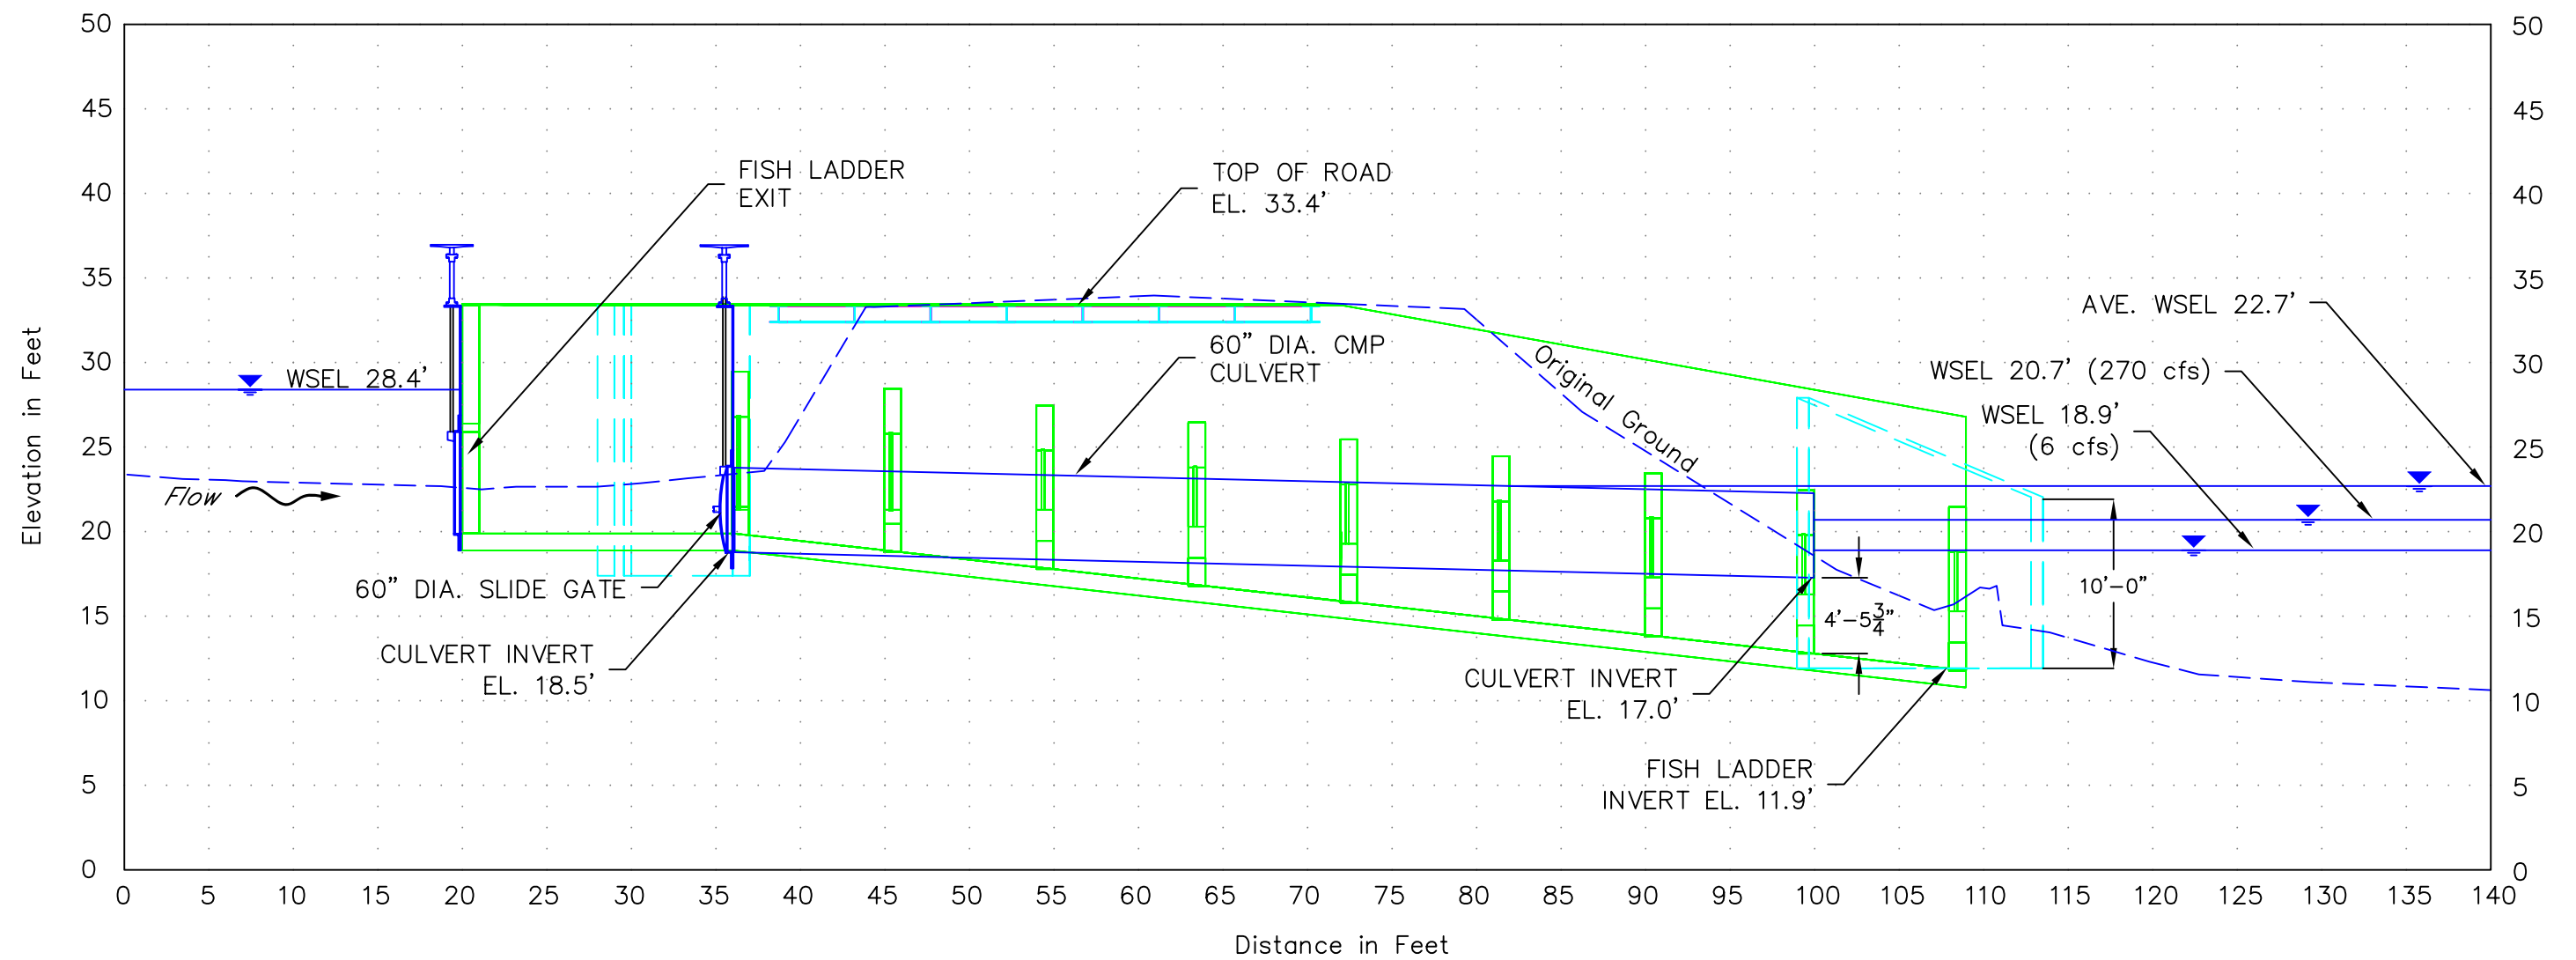
Drawing:
Ladder_Culverts
Sheet 7 of 8

- 1) Vertical datum NAVD 88, feet (add 0.6' to get USED datum).
- 2) Survey performed December 2000.
- 3) Cutoff walls not shown.
- 4) Footings not shown.

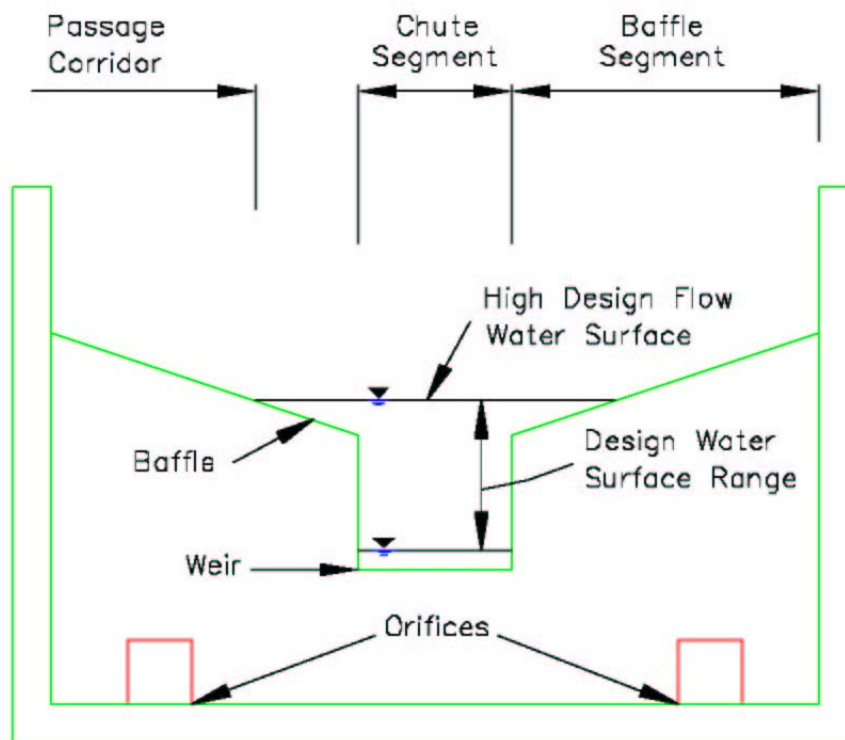
Figure 1. Elevation view of Pool and Chute fishway with nomenclature.

The Pool and Chute fish ladder concept was first presented by Ken Bates from Washington Department of Fisheries in 1991. It is a hybrid type fishway that operates in two flow regimes; plunging and streaming flow. The geometry and nomenclature of the Pool and Chute fishway are shown in Figure 1. It is essentially that of a pool and weir fishway with V-shaped weirs. The basic layout consists of a center weir section and two higher sloped baffles on the end of each weir. The width of the plunging flow regime is considered the passage corridor. The flow into the fish ladder is regulated by the first weir. Stop logs or bulkheads are used to isolate the ladder.

At low flows the fishway operates like a pool and weir fish ladder. Water spills over the weir and fish pass upstream by either leaping over the sloped baffles or swimming through the orifices. At higher flows, the water is streaming down the chute segment of the fishway at a higher velocity. Upstream fish passage is provided through the chute segment where the sloping baffles create a plunging flow and a passage corridor but most of the fish passage occurs within the orifices. Bates developed preliminary design standards based on a hydraulic model study that was developed for the Town Diversion Dam fishway on the Yakima River in Washington State (Powers, 2000).

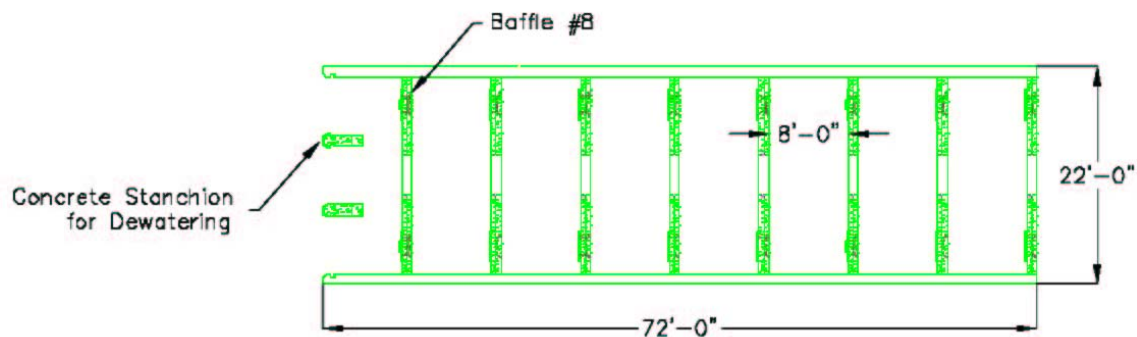
Figure 2. "Standard" 8 Baffle Pool and Chute fish ladder.

The proposed fish ladder for Willow Slough is a Pool and Chute fishway. In California, at least two 8 baffle/8-foot head differential Pool and Chute fish ladders have been constructed and are operating well (Figure 2). The proposed design at Willow Slough deviates from previous designs in California by the addition of a headgate structure that consists of two 4 x 6 foot gates and a 5-foot wide weir and a ninth baffle with a 10-foot head differential (Figure 3). The two 4 x 6 foot gates are intended to create up to 1-foot head loss when a 10-foot head difference between the East Borrow Canal and Willow Slough exists. The 5-foot wide weir is used for a low flow scenario.

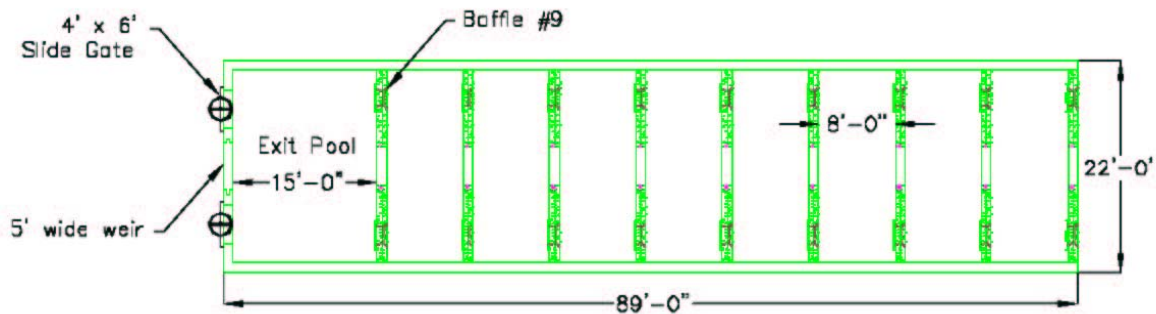
Figure 3. Proposed Pool and Chute fish ladder with headgate structure.

At the request of George Heise, the existing 1:12 scale model was modified by DWR by adding a ninth baffle and a headgate structure in front of the upstream baffle. The Parrott-Phelan 1:12 scale model was modified to determine whether a ninth baffle and headgate structure will cause hydraulic instability. The model was tested at the Coleman National Fish Hatchery near Anderson, California during the week of October 6th, 2003.

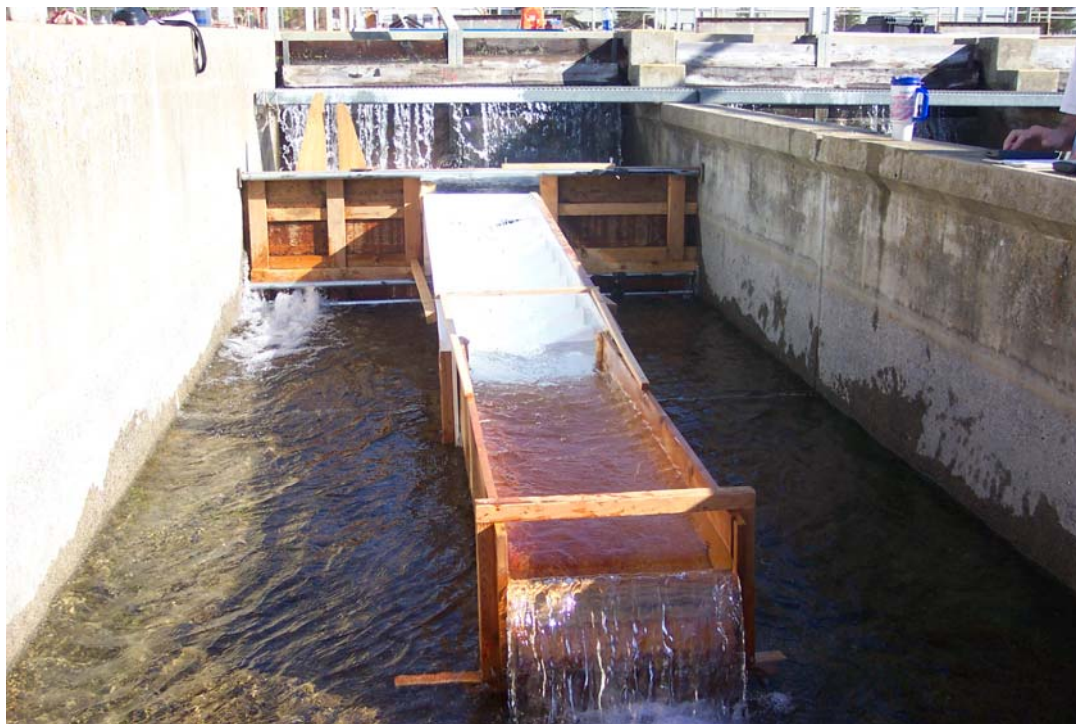
Figure 4. Pool and Chute fish ladder set-up

The fish ladder, shown in Figure 4, was then placed within the headwall and foam was used to help secure the fit and minimize leaks between the ladder and headwall. The tailwater pool was connected to the bottom of the fish ladder. The boards at the end of the pool were used to vary the tailwater conditions.

The slope of the fish ladder was measured using a survey level and rod to ensure the correct slope of 11.1 percent was accurate. Water was then released down the raceway into the fish ladder to begin testing. Two slide gates were installed in the headwall to regulate the upstream water surface elevation. Once the upstream water surface elevation reached a steady state, a total of seven different runs were simulated.

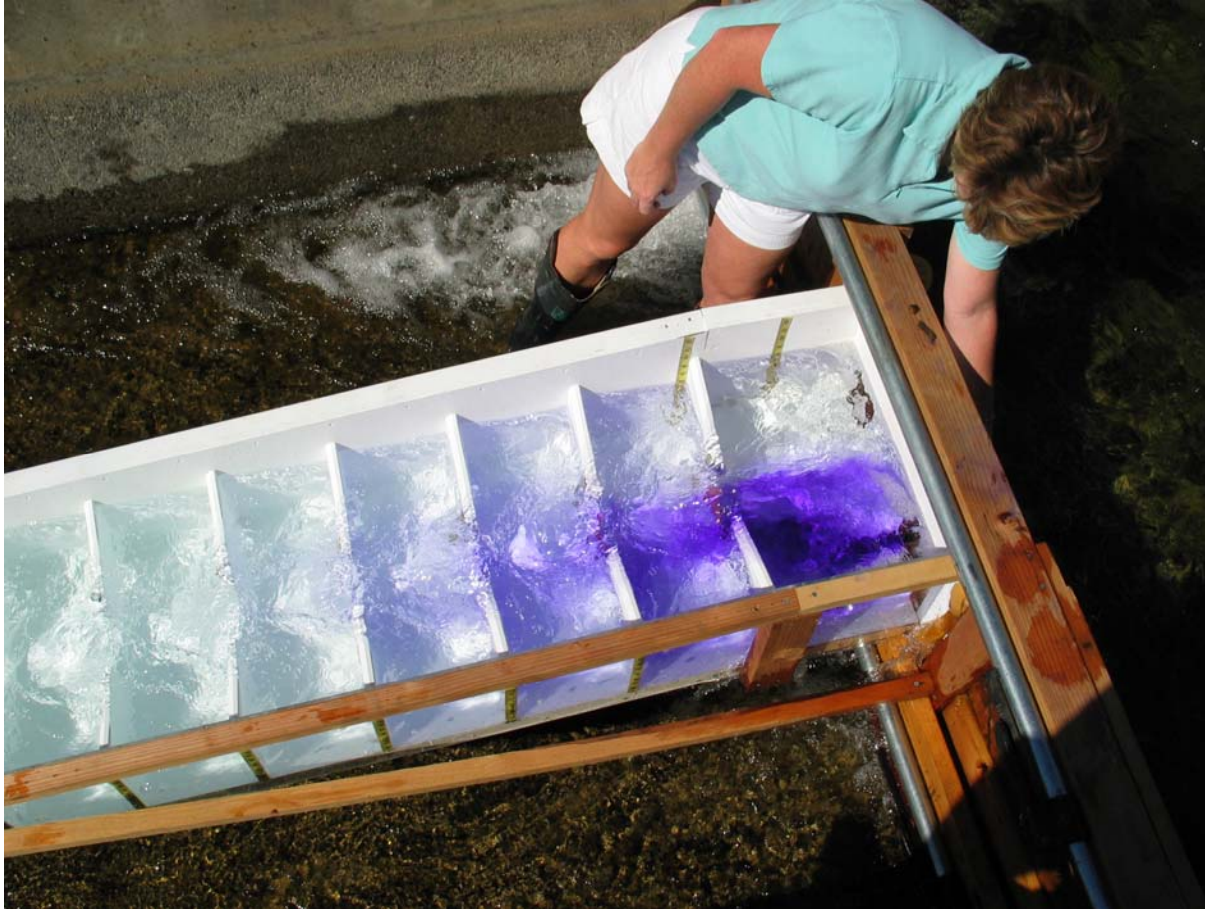
Figure 5. Dye injection at the headgates.

Tracing dye was used in all runs. The dye was diluted with water and placed in two 500ml wash bottles. The dye was injected predominantly at the headgates, shown in Figure 5, and various places throughout the fish ladder to help detect any unusual hydraulics throughout the fish ladder.

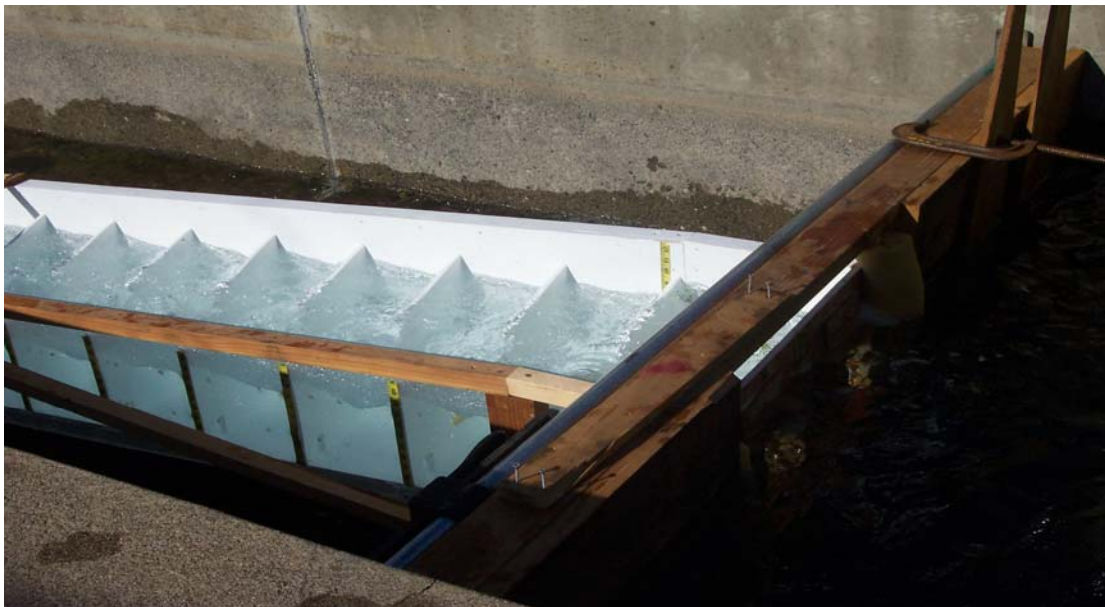
Figure 6. Simulation of Run 7.

Run 7 simulated a high flow event with a 10-foot head differential, but the headwater was raised by 0.5 feet to the higher simulated operating water surface elevation of 29.5 feet. All the pools were turbulent and the water level across the uppermost baffle was approximately two-thirds up the sloped baffle as shown in Figure 6. All of the flashboards were taken out of the first two baffles to see if the water level would drop or the turbulence would decrease, but little to no change occurred. The water level dropped along the sloped baffles as the water traveled downstream through the fishway thus decreasing the passage corridor. Dye was injected in the chute section and little mixing occurred, though some circular patterns emerged. Dye was also injected behind the uppermost baffles and there was definite evidence of slower velocities. When the dye was injected in the orifices, there was almost complete mixing although some dye managed to streamline to the next orifice.

All of the runs with the exception of the simulated low flow events, runs 4 and 5, showed visible signs of water boiling over the first baffle. As water enters the fishway through the two 4 x 6 foot headgates and flows into the first baffle, the water noticeably rises up at that baffle and causes a boiling effect over the baffle. This boiling effect was noticeably worse as the flow and head difference across the headgate structure increased.
